Re: Outfall 300 – Sanitary Sewer Overflow Annual Report

City of Canton
Stark County, Ohio

SANITARY SEWER OVERFLOW
2013 ANNUAL REPORT

PERIOD COVERED BY REPORT: January 1, 2013 - December 31, 2013

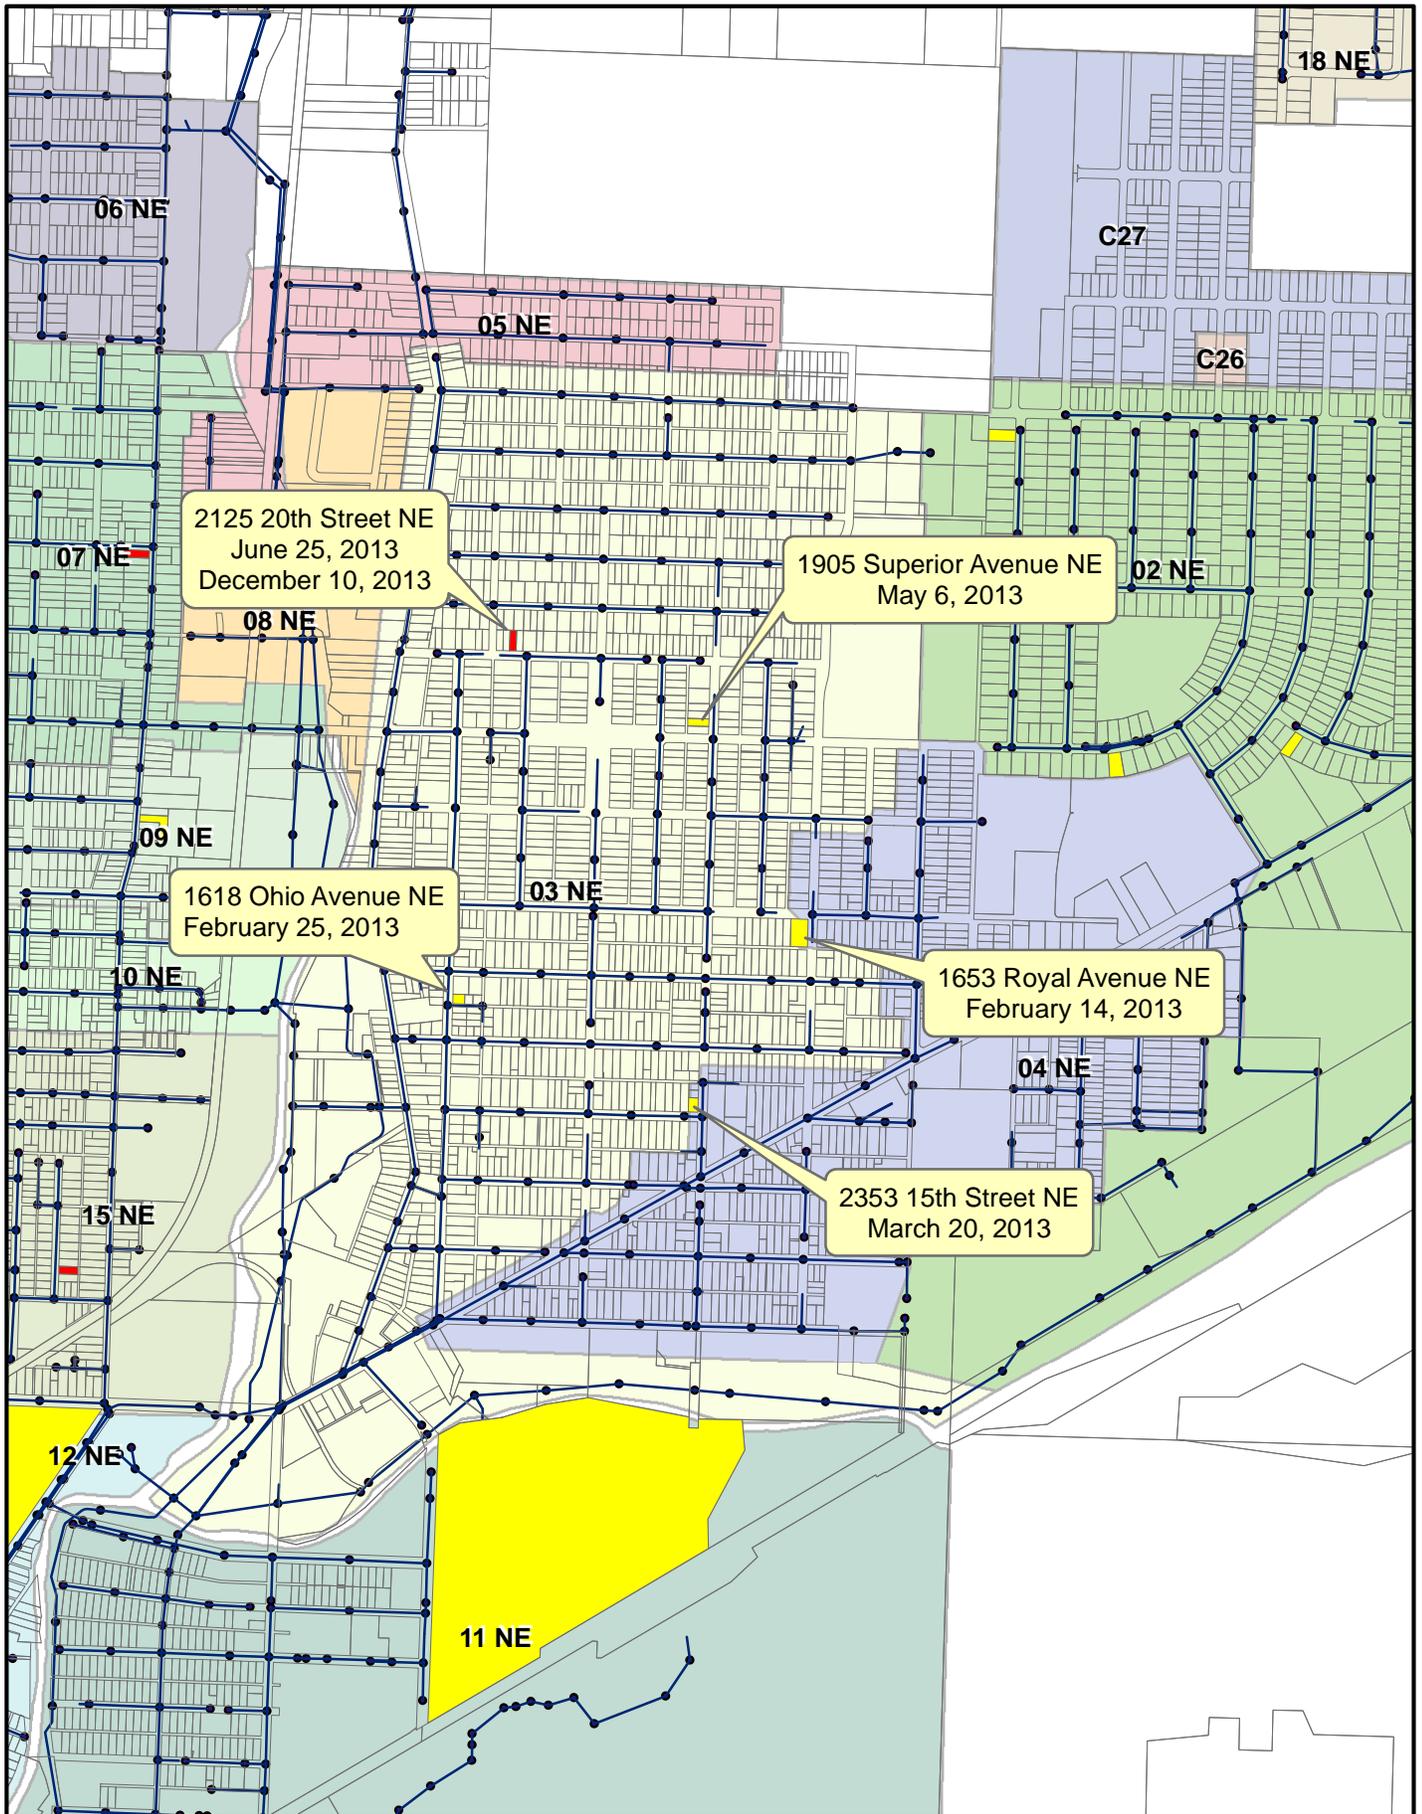
**City of Canton, Ohio - Outfall 300 - March 2014
WIB ANALYSIS - SEWERSHED 03 NE**

The six (6) public WIB's reported in sewershed 3 NE were all reported on separate dates and at five (5) different locations. On one occasion, an atypical obstruction (broom stick) was removed from the public sewer. Several of the other 5 occurrences were in locations near the start of a line. These areas will continue to be monitored in the future for additional reports of WIB. As warranted, additional remediation will be initiated.

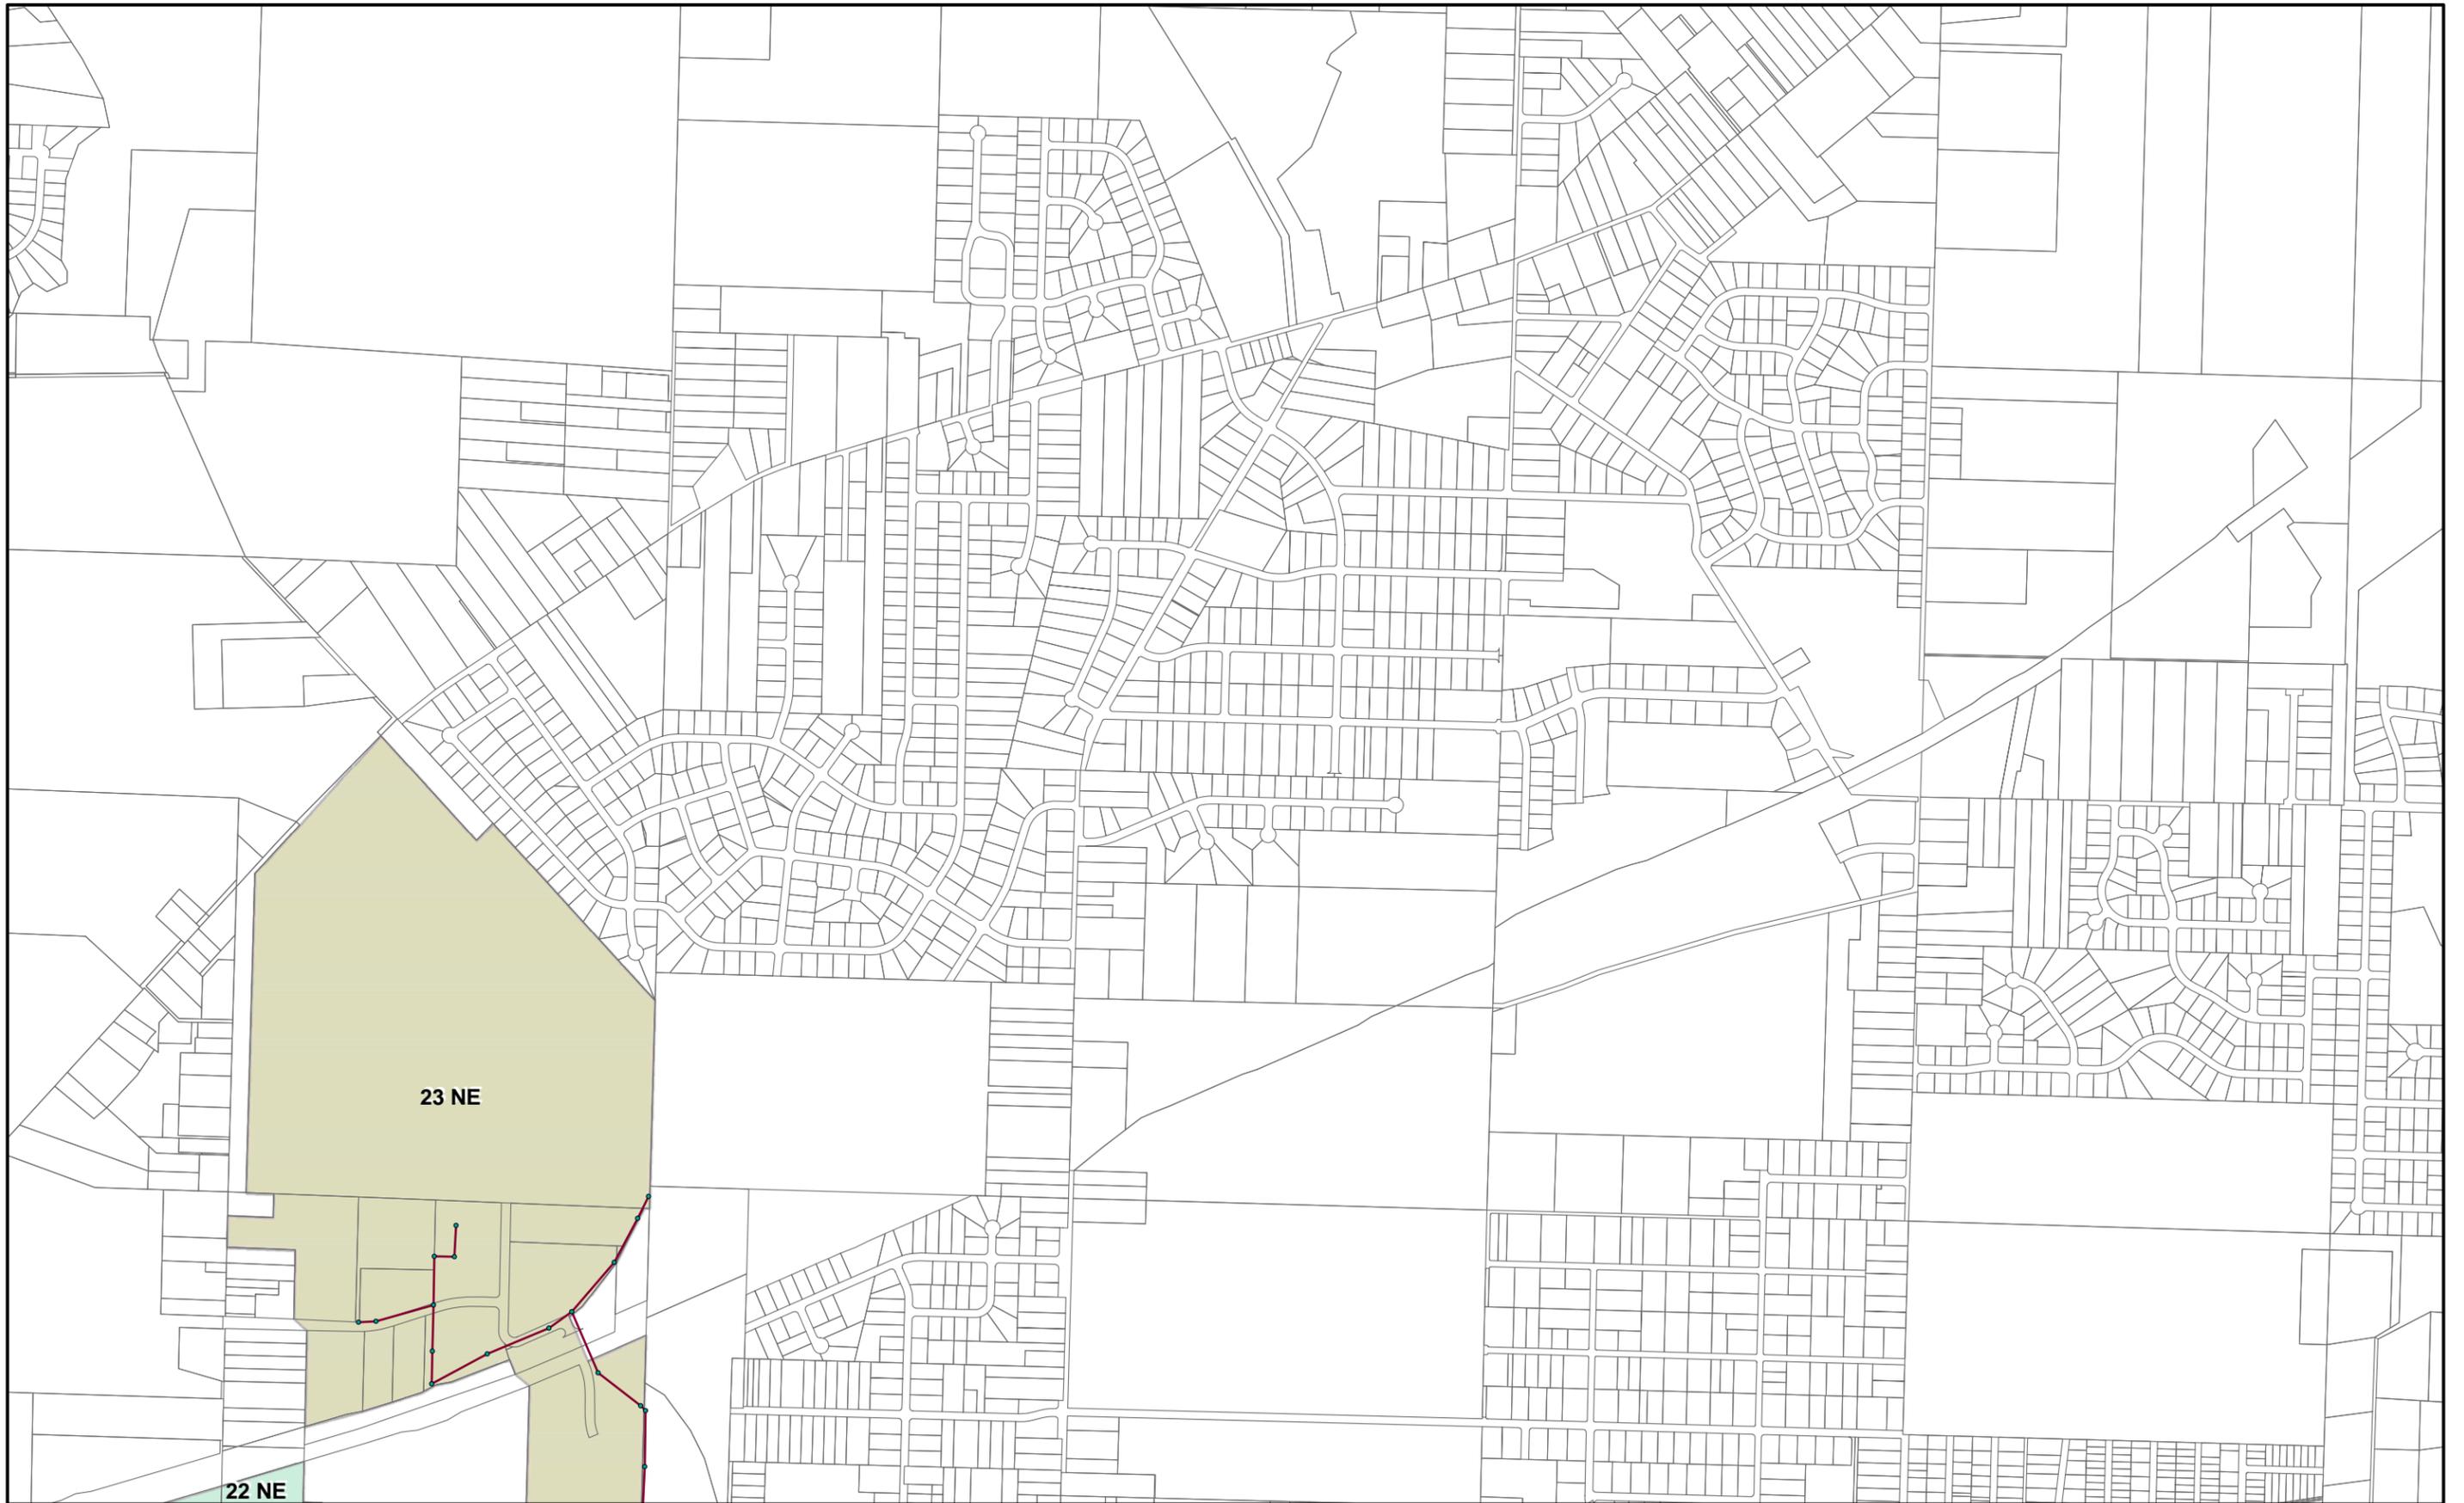
**City of Canton, Ohio - Outfall 300 - March 2014
WIB ANALYSIS (PUBLIC OCCURRENCES)**

In the past, the City has performed Inflow and Infiltration (I/I) Studies and Sanitary Sewer Evaluation Studies (SSES), via engineering consultants, to evaluate the condition of the sanitary sewer system. In these studies, the system was divided into several sewersheds. The enclosed drawings, collectively called Appendix A, identify the sewersheds as included in the previous SSES's. For the purpose of this annual report, we have utilized these sewersheds to determine the number of Water in Basement (WIB) occurrences reported in each. Areas outside of the limits of the previous engineering studies have since been added in a manner consistent with the previous studies.

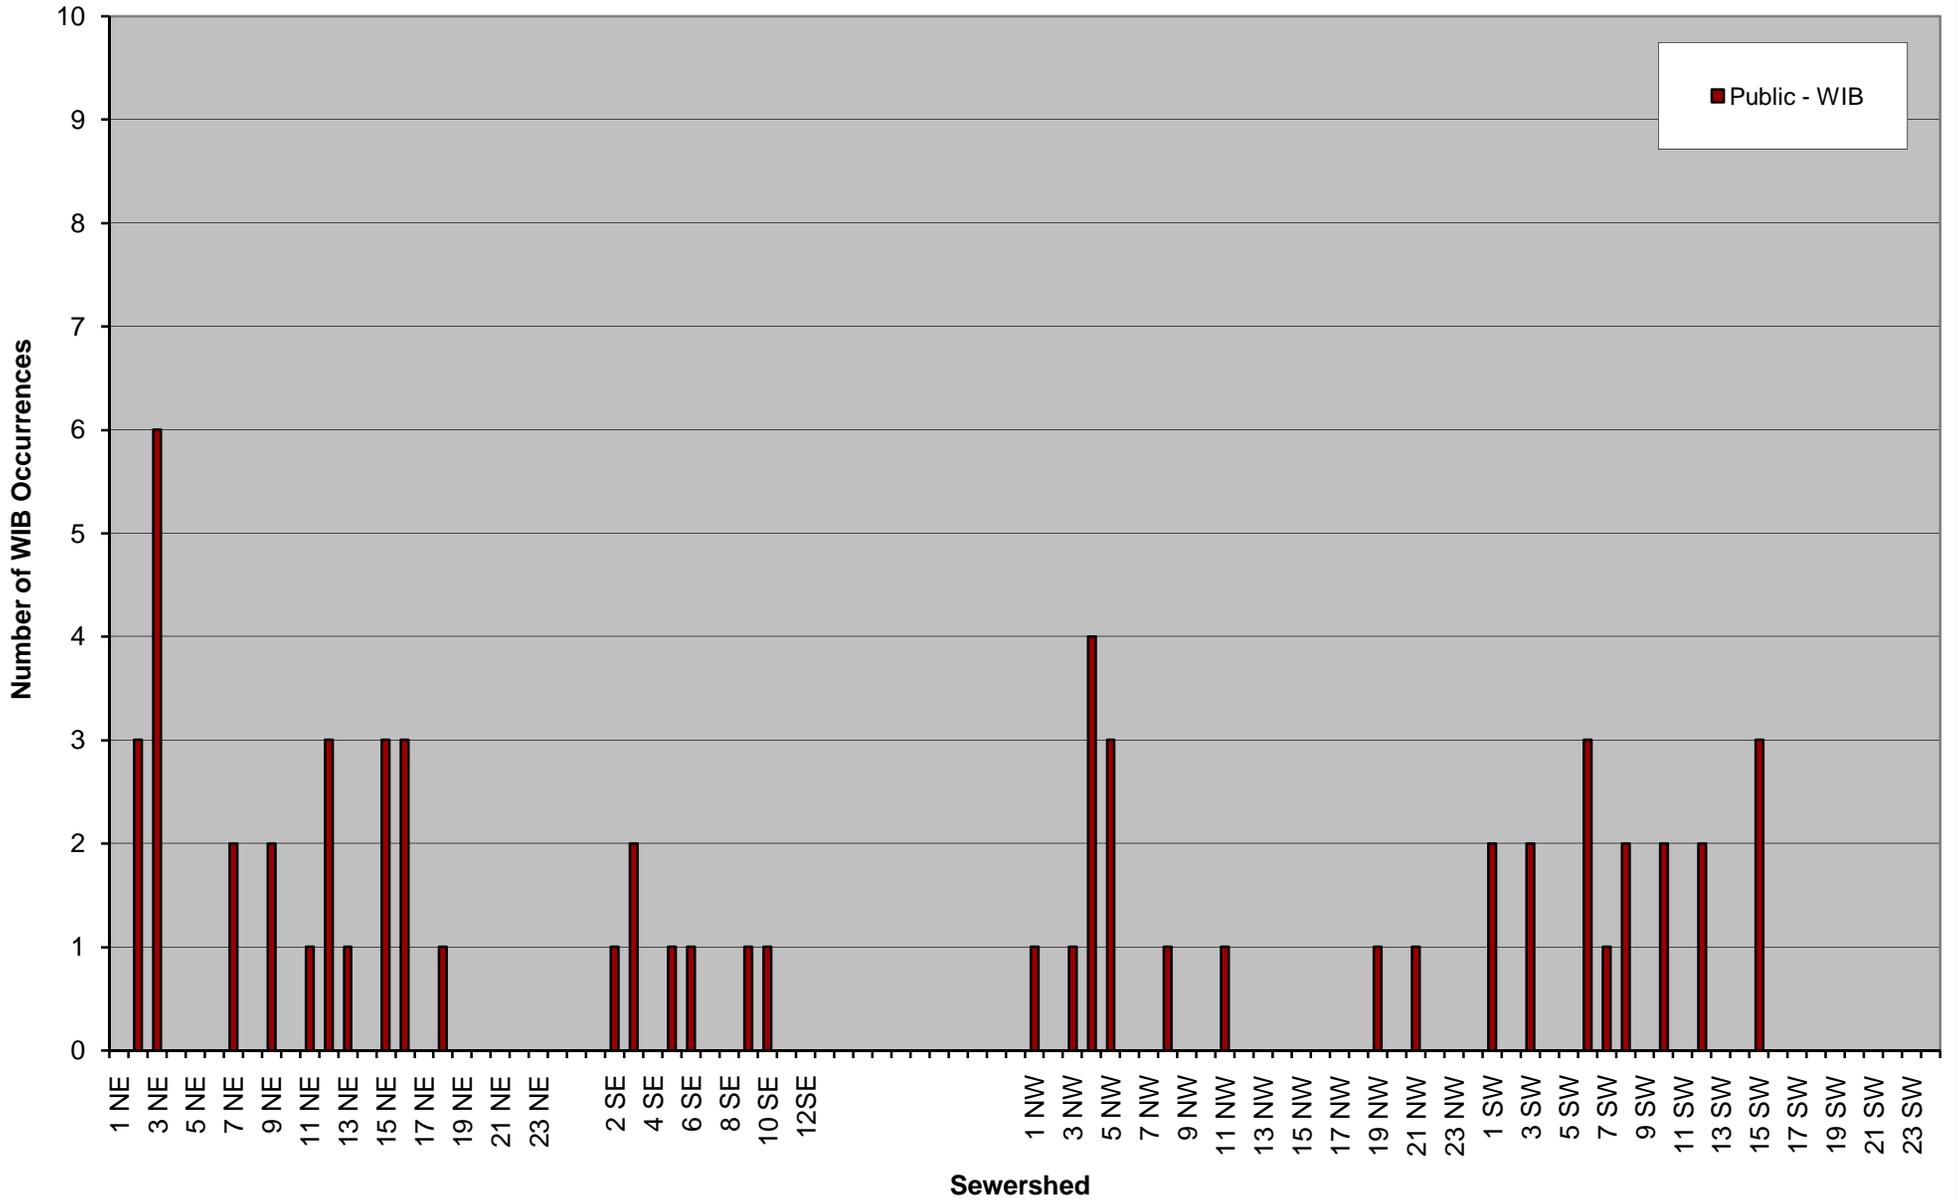
**ATTACHMENT B1
WIB OCCURRENCES BY SEWERSHED (NE QUADRANT)**

We have also created spreadsheets and charts of each reported WIB based on sewershed. This information is included in Appendix B. Based on this information, we are performing this analysis of WIB patterns by location, frequency and cause.
